## IV. Analysis and Evaluation

The analysis and evaluation of the cultural landscape for the Lincoln Memorial grounds are based on an examination of the historical records and the documentation of existing landscape resources in the study area. A summary discussion of the cultural landscape components documents landscape patterns, relationships, and individual features within a site, which define the character of the designed landscape. With this information, the overall significance and integrity of the landscape is addressed according to national register criteria for landscapes.

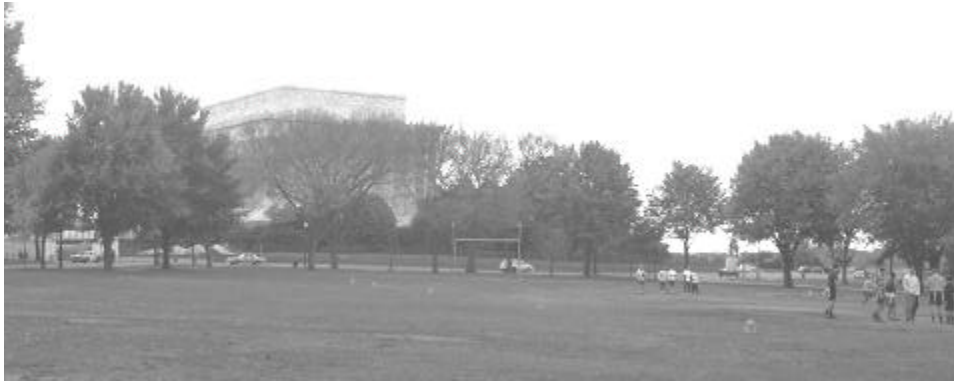
***Figure 36 - Grassy area north of Lincoln Memorial is used for active recreation, November 1996. LINC 11-29.***

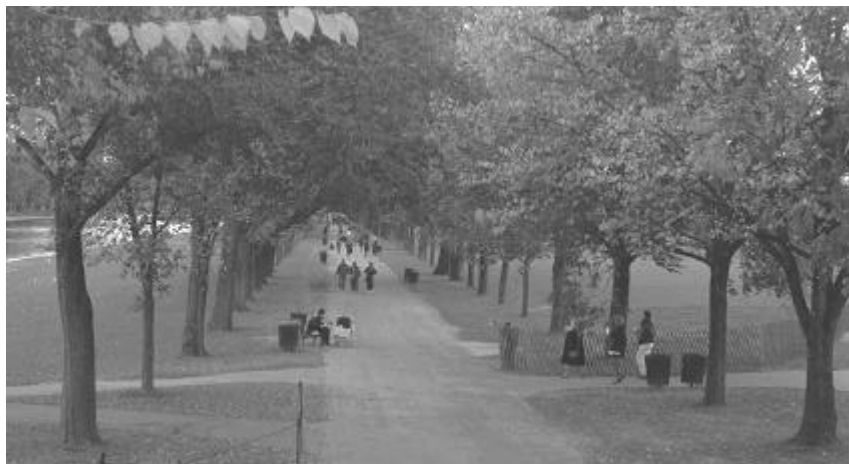
***Figure 37 - Visitors walking along the south Reflecting Pool path, November 1996. LINC 11-30.***

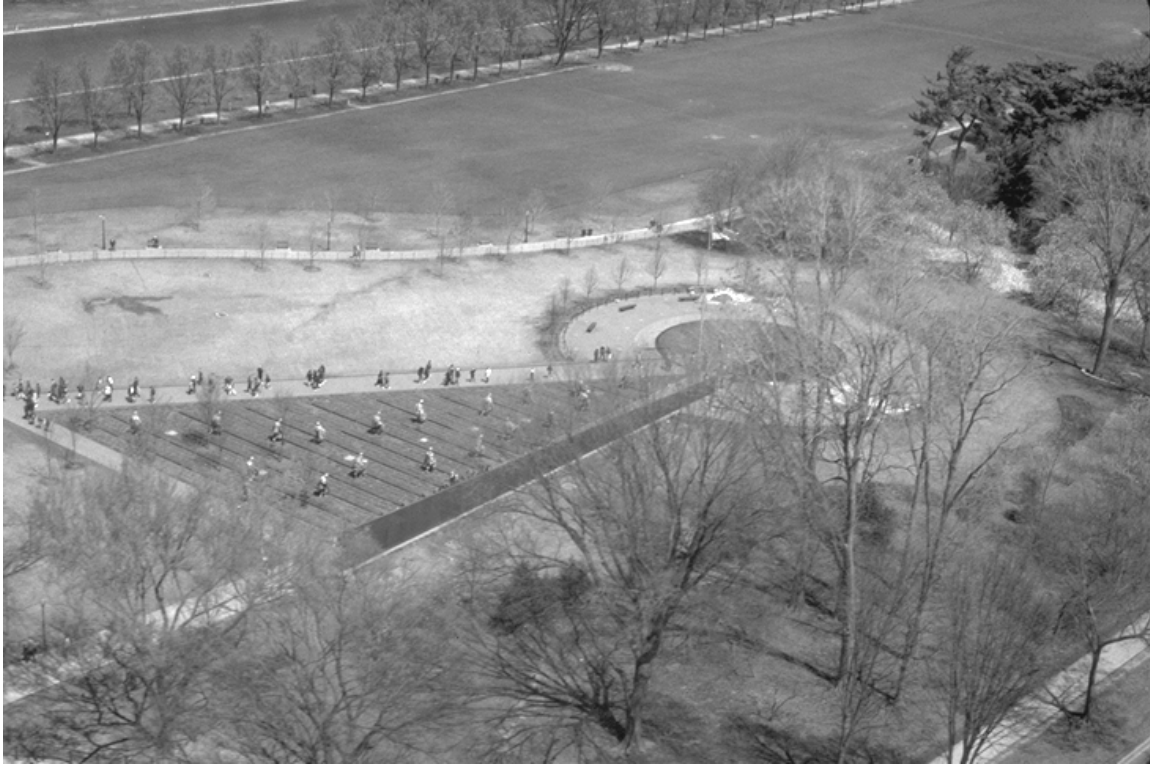
**Figure 38 - Aerial view of the Korean War Memorial and its impact on the open grassy area south of the Reflecting Pool, April 1996. LINC 3-32.**

The area south of the Reflecting Pool developed in a different manner. The upper part of the space remained open, while the lower portion, flanked by an old road, was maintained as a tree grove. Even though there was no specified use for this area, its relationship to the design of Reflecting Pool area was important. Both the McMillan Commission and the National Capital Parks and Planning Commission emphasized the juxtaposition of open areas (grass fields) and enclosed areas (tree groves) in their plans. Within the trees, a classical pavilion was constructed to honor D.C. citizens killed in World War I. The area remained in this state until 1942 when the government built temporary buildings on the open land. In 1964 these "tempo" were removed and the area was once again an open grassy field. After 1964 the open field was used for special events and active recreation. Subsequent changes did not occur until 1995 with the installation of the Korean War Veterans Memorial on the western portion of the open field. As with the Vietnam Veterans Memorial, the Korean War Veterans Memorial had a symbolic relationship

Although the Vietnam and Korean memorials and Constitution Gardens are known for their distinct designs and cultural value, these were developed independently of the historic Lincoln Memorial grounds. In addition, the change in land use from passive to active recreation on the south side of the Reflecting Pool detracts from the original design planned for this area. See Map 9 *Overall Landscape - Land Use* for delineation of adjacent use areas.

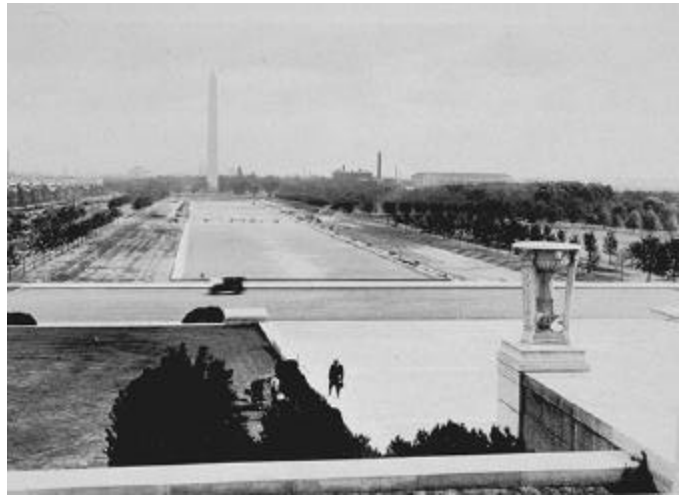
*Figure 39 - Main mall axis view from the raised terrace of the Lincoln Memorial to the Washington Monument, October 27, 1922. MRC 3-2.*

As defined in the 1791 L'Enfant plan and subsequent McMillan Commission Plan of 1901, the most important designed vista is the main mall axis, from the steps of the Lincoln Memorial east to the Washington Monument and then from the Capitol to the Washington Monument to the Lincoln. To help frame the view and provide an unobstructed vista, double rows of elms were planted on either side of the Reflecting Pool. The vista narrowed at 17<sup>th</sup> Street where the street trees (American elm) framed the view to a controlled 160-foot opening (the same width of the Reflecting Pool). A continuation of this axis went from the west side of the Lincoln Memorial to the Watergate steps and across to the Virginia shoreline. Two other sight lines radiated from the rear side, or west side, of the Lincoln Memorial to maintain the symmetry of the design. One was to the southwest across the Potomac River to Arlington Cemetery and Arlington House, and the other was to the northwest to Parkway Drive. The fan-shaped view zone to the west is framed by white pines and elms, planted on the outside edge of the bridge and parkway approaches to Lincoln Circle. Views from the Ericsson Memorial, south of the Lincoln and along 23<sup>rd</sup> Street NW to the north provide secondary views to the Lincoln Memorial. All of these significant view zones are evident today in various degrees. However, the foundation plantings around the Lincoln Memorial are encroaching upon the openings at the base of the raised terrace wall on the north and south facades. This is more evident on the center of the north side of the memorial where the branches of hollies are arching over lower, horizontal-growing yews. After the completion of the Lincoln Memorial grounds in the 1930s, additional views from subsequent memorials to the Lincoln Memorial were emphasized based on their relationship to the Lincoln. This is evident from the Jefferson, Vietnam Veterans, and Korean War Veterans Memorials. Since these offsite views do not relate to the original design intent of the Lincoln Memorial grounds, they are noncontributing features to the overall

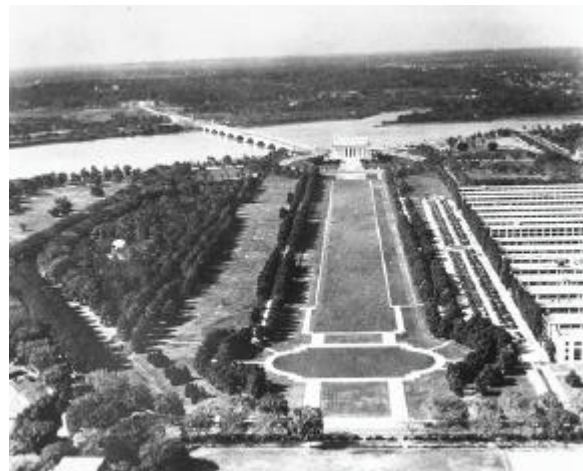
*Figure 40 - View from the Washington Monument to the Lincoln Memorial, c. 1930. Trees along 17<sup>th</sup> Street left an opening for the main mall axis view. MRC 3-26.*

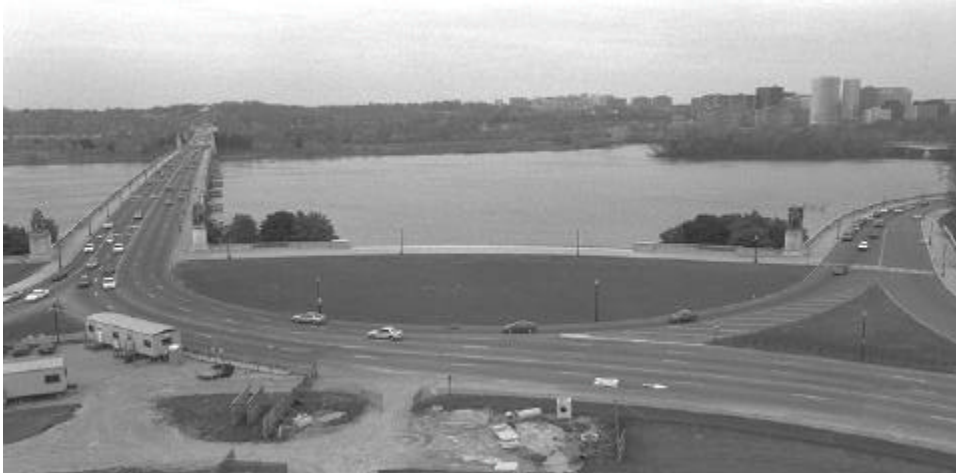
*Figure 41 - View from roof of Lincoln Memorial to the Virginia shoreline, March 11, 1996. LINC 6-22.*

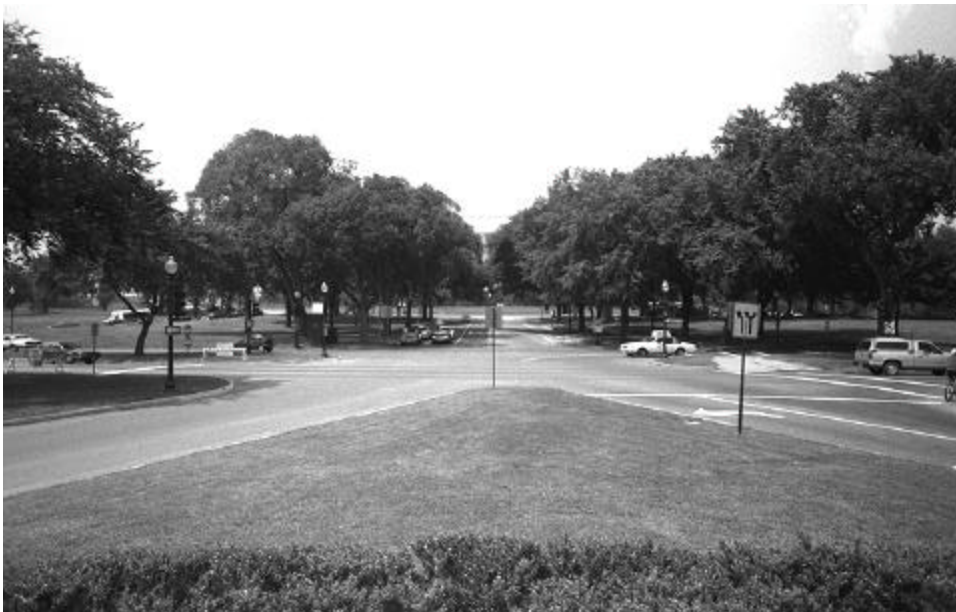
*Figure 42 - Limited view of Lincoln Memorial from the Ericsson Memorial, June 1996. LINC 9-7.*

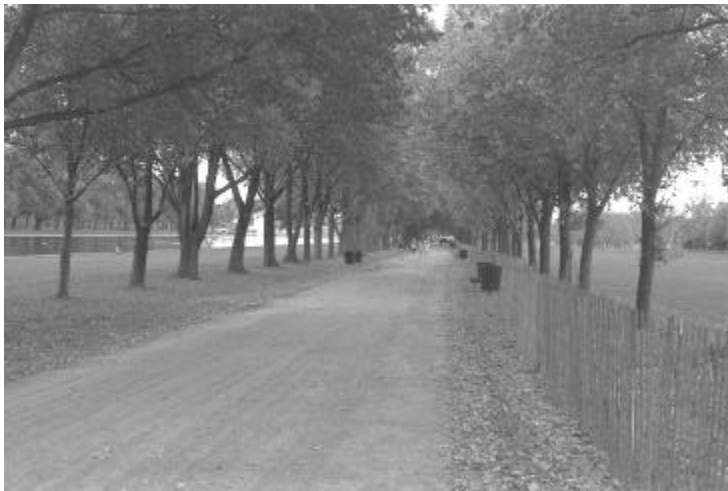
*Figure 45 – Elm walk on south side of Reflecting Pool, November 10, 1996. LINC 11-35.*

been planted originally.<sup>85</sup> Presently, most of the Reflecting Pool elms are Dutch elms with a few smoothleaf, American, English and Scotch elms (*Ulmus carpinifolia*, *Ulmus americana*, *Ulmus procera*, *Ulmus glabra*) planted in between. Olmsted's elm selection suggests a conscience decision to define a different tree form for this area. English elms that did not survive have been replaced in the same locations, but with other more sturdy and Dutch elm disease-resistant species. Such replanting has created a corridor of trees of varying heights, crowns and circumferences. The smaller number of mature elms on the south side of the Reflecting Pool may be due to compacted soil in this area. High levels of pedestrian traffic passing between the trees to the adjacent athletic fields, as well as the trees proximity to flood prone areas of the park, may have brought about this condition. On the north side there are more mature elms. These elms are subject to less drainage problems and less compaction from recreational and pedestrian activity. The presence of a flood control berm also discourages walking between the trees to Constitution Gardens. Only a few designated paths cross over the berm, which limits impact to the elms in this area.

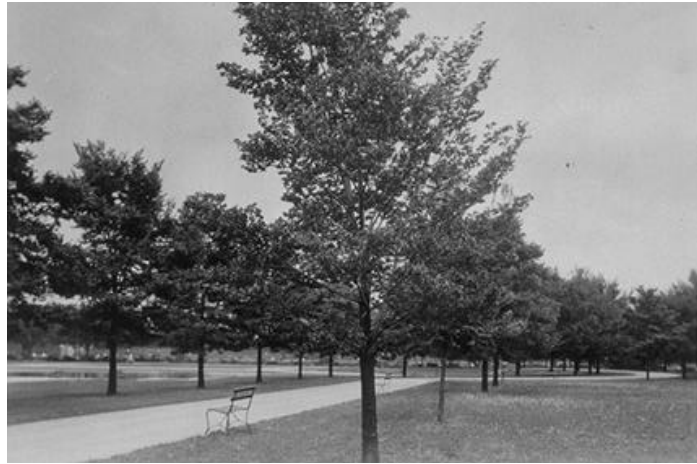
*Figure 46 – Young elms line concrete walks by Reflecting Pool, May 1929. MRC 2-40.*

Pedestrian circulation in the Reflecting Pool area has had a few minor changes since the paths were first laid out. The original plan called for two 15-foot-wide concrete paths situated under the double row of elms, running east to west to serve as the primary pedestrian route along the pools. On the west end of the walkway, two sets of steps brought pedestrians from the lower pool area up to the memorial circle. Sometime before 1964, an additional

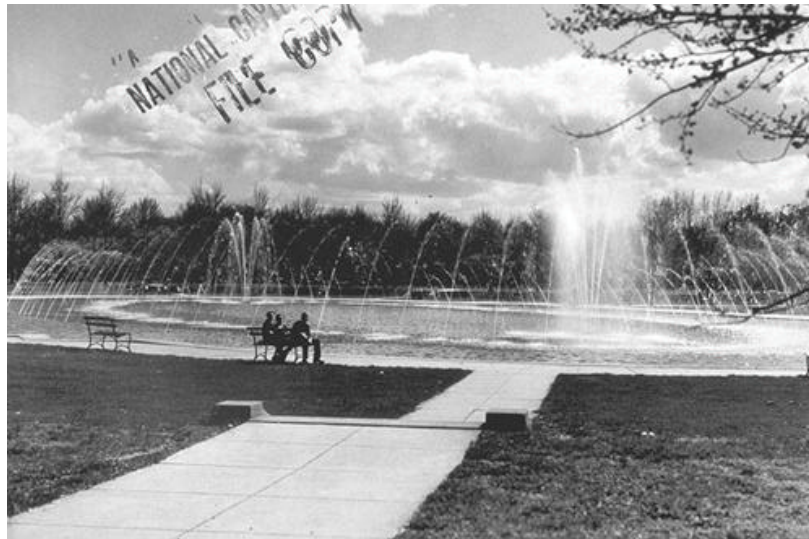
*Figure 47 - Concrete walks radiating from the Rainbow Pool, April 1933. MRC 2-126.*

Two sets of three 6-foot-wide paths, extending in radial lines from the Rainbow Pool, provided connections to selected points along the main walks on both the north and south sides and promoted circulation around the pool. A concrete plaza area surrounded the Rainbow Pool, which gave visitors a closer vantage point from which to enjoy the fountain display.

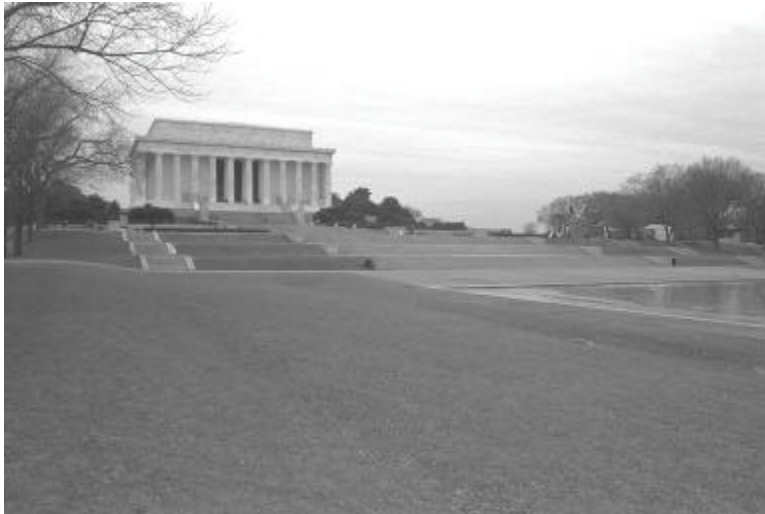
*Figure 48 – Reflecting Pool steps and plaza on west end of pool, November 11, 1996. LINC 11-13.*

Access to the Reflecting Pool from the memorial consists of a series of granite steps descending from the circle and adjacent sidewalk down to the pool's western

edge. The line of these steps continues the line established on the opposite side of the circle by the main approachway leading up to the memorial structure. One broad stairway and two narrow stairs comprise the series. In 1924 a flagstone paver walk, leading from the set of narrow granite stairs and across the grassy strip bordering the pool, connected the descent to the granite coping. These pavers were removed in the 1970s, and in their place a new plaza was installed. As discussed earlier, two other sets of stairs, constructed of concrete, flanked the larger granite series. These steps connected the concrete paths between the double rows of elm trees with the walk around the memorial circle.

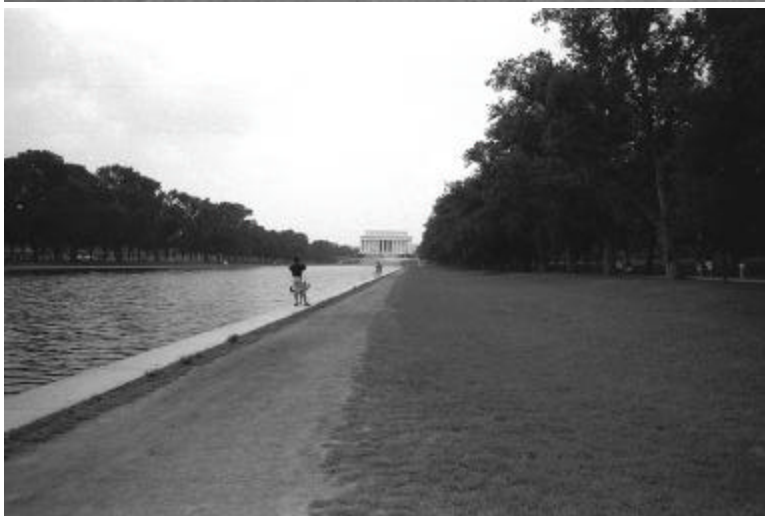
*Figure 49 – Worn path adjacent to granite coping, June 1996. LINC 9-23.*

Although narrow and not designed or designated for pedestrians, visitors also used the granite coping of the Reflecting Pool as an alternative walkway between the Lincoln Memorial and the Washington Monument.

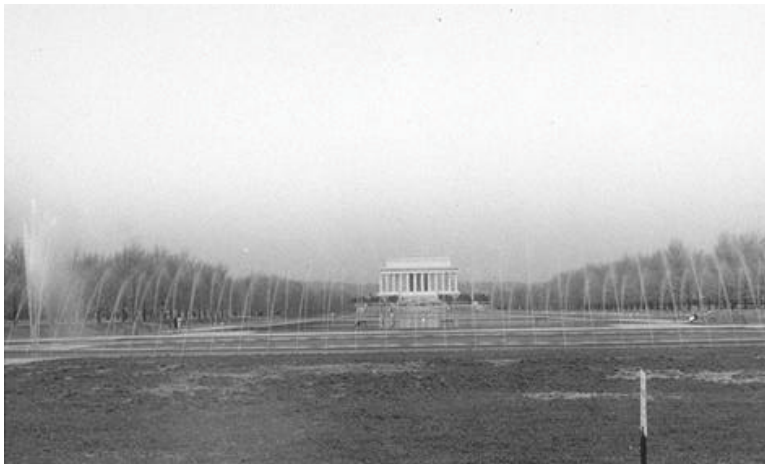
*Figure 50 – Rainbow Pool fountain display, April 20, 1934. Photo by Kelly. MRC 2-108.*

Fountains were installed in the smaller pool, in 1924. An oval pattern of 124 nozzles sprayed approximately 25 feet in the air towards the middle of the pool creating a rainbow affect on sunny days. In addition to these jets, two other clusters of nine jets on the north and south side of the pool towered above forming a fountain 40 feet high. A year later, the Commission of Fine Arts inspected the fountain and indicated that the fountain's height and intensity of spray obscured the views to the Lincoln Memorial and Washington

Monument. A series of tests were conducted in 1934 to determine the most appropriate and effective display and to meet the CFA's requirements. In 1990 some of the nozzles were replaced with a straight head type. It is unknown if this has altered the jet display that was originally approved by the Commission of Fine Arts in the 1930s. Currently only the two clusters of jets on the north and south side of the pool are operating and the oval pattern on the outer edge of the pool is not used. Because of this the fountain no longer sprays at the height required to exhibit a rainbow effect but instead appears as a weak imitation of the past display.

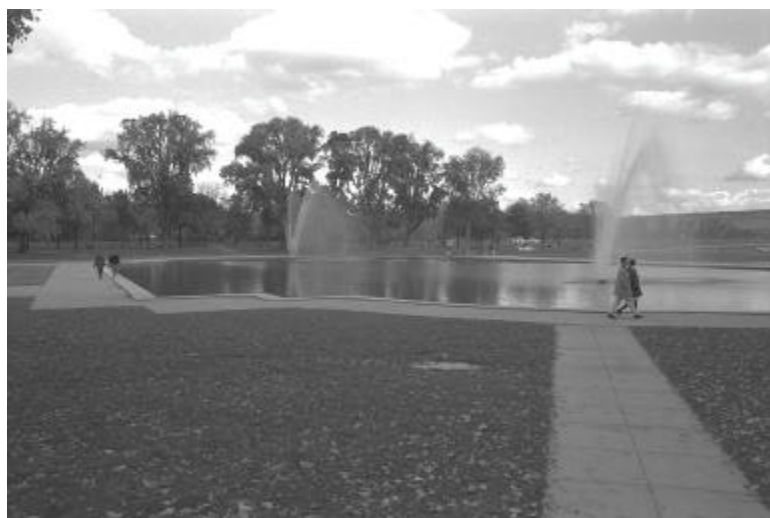
**Figure 51 – Rainbow Pool fountain as it appeared on November 11, 1996. LINC 11-10.**

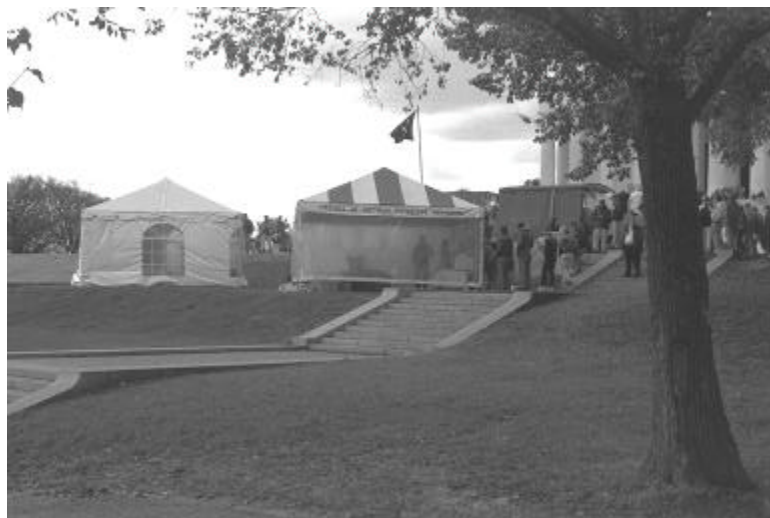
**Figure 52 - Temporary structures on grassy terrace by Reflecting Pool steps, November 11, 1996. LINC 11-22.**

the plaza at the top of the granite stairs. These are owned by vendors who have obtained a special use permit to sell t-shirts and other products under a First Amendment ruling. To reduce the impact on cultural and natural resources the NPS has tried to limit where the vendors operate. The unsightly tents obscure the view along east/west axis from the memorial, the approachway, and the Reflecting Pool. See Map 13 *Reflecting Pool area - Structures* for location of structural features.

In addition to the main structural features of the Reflecting Pool area, there are temporary structures located both north of the Rainbow Pool and in the northwest corner of

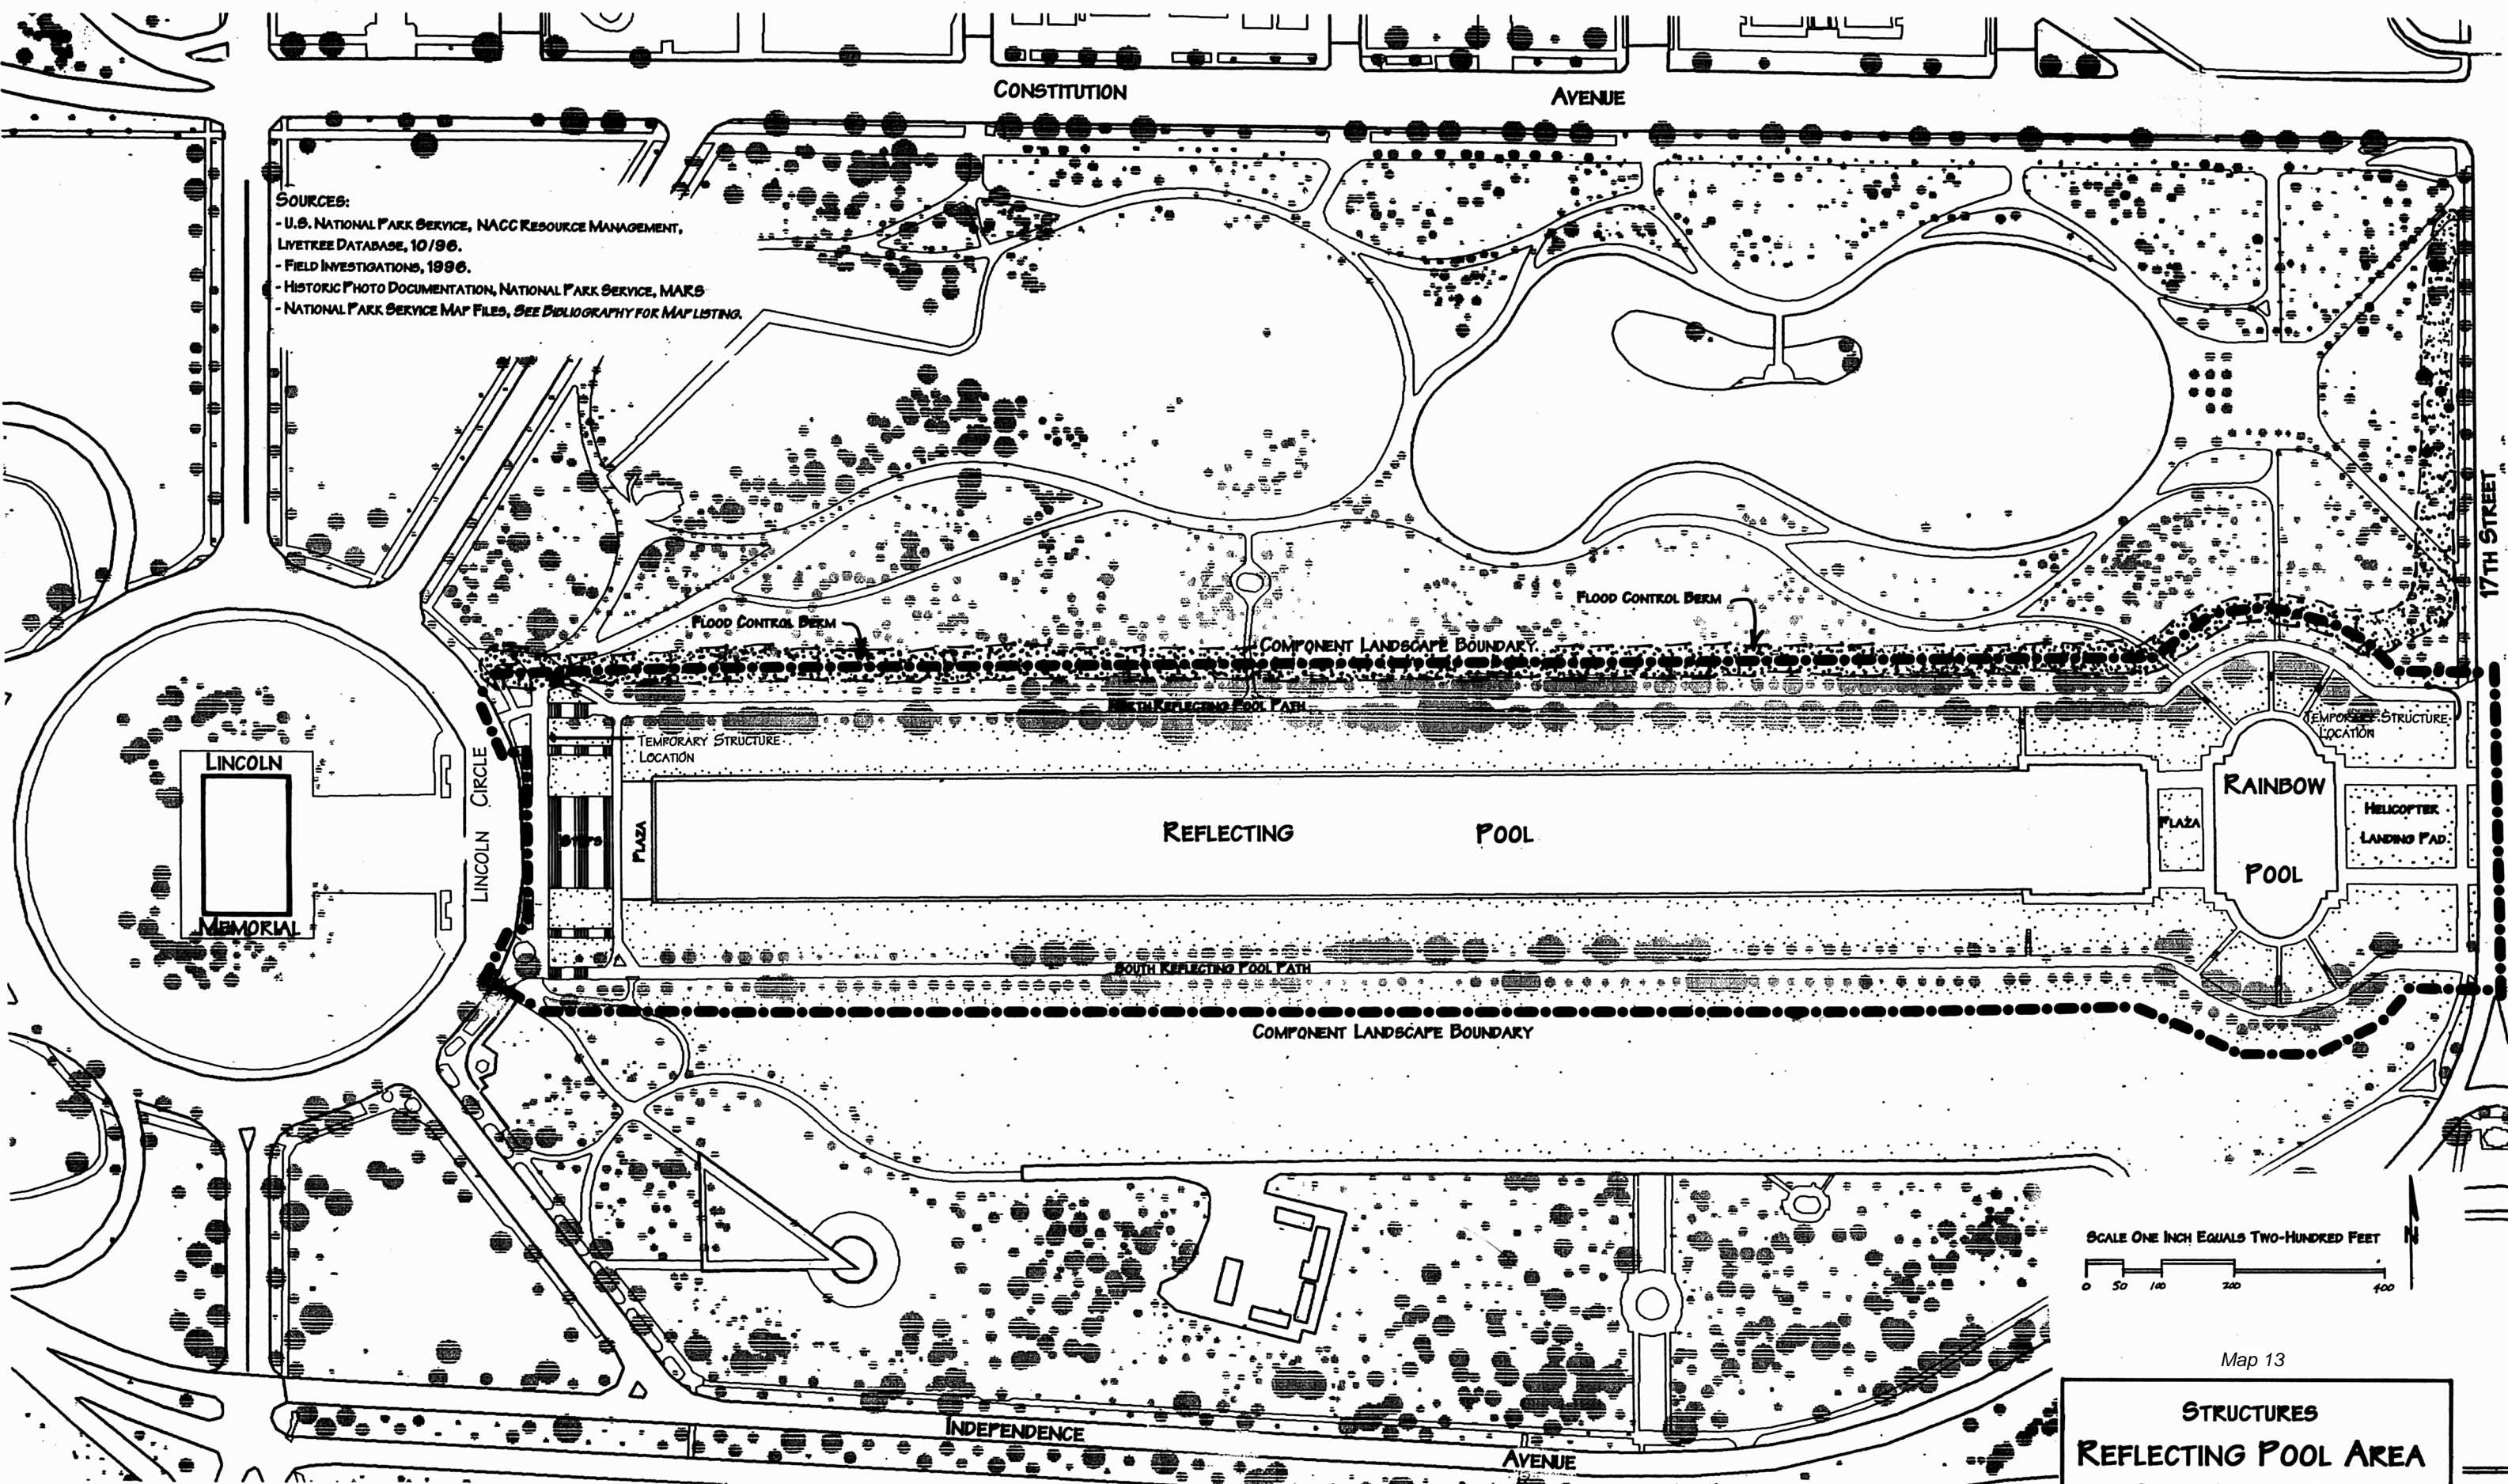
Map 13

SOURCES:  
- U.S. NATIONAL PARK SERVICE, NACC RESOURCE MANAGEMENT, LIVETREE DATABASE, 10/86.  
- FIELD INVESTIGATIONS, 1986.  
- HISTORIC PHOTO DOCUMENTATION, NATIONAL PARK SERVICE, MARKS  
- NATIONAL PARK SERVICE MAP FILES, SEE BIBLIOGRAPHY FOR MAP LISTING.

**STRUCTURES**  
**REFLECTING POOL AREA**

<b>Contributing Features</b> 1. Reflecting Pool 2. Rainbow Pool 3. Reflecting Pool steps	<b>Noncontributing Features</b> 1. Temporary structures for use by vendors
---	---

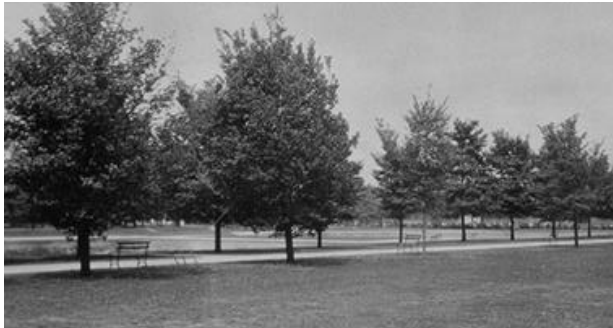
**Figure 53 – Cast iron frame benches placed along elm walks, May 1929. MRC 2-48.**

**Benches.** In the Reflecting Pool area, the earliest photographs show benches spaced evenly, approximately 50 feet apart, along the walkways and underneath the outer row of trees in the double rows of elms. A few benches were also placed under the inner rows of trees. All of the benches were situated facing the Reflecting Pool. Groups of benches were also placed around the Rainbow Pool for viewing the fountain in the summer months and for the use of ice skaters in the winter. The benches appear to have been moveable and not permanently mounted. The type of bench utilized during the 1920s and 1930s is similar to the present bench, a cast iron frame with a wooden slat seat and back. However, the smaller number of benches found along the walks today and their permanent, fixed positions reflect the change in contemporary uses. These changes include the removal of benches from around the Rainbow Pool and the reorientation of all seating underneath the inner rows of trees away from the Reflecting Pool, toward the walkways, facing the opposite benches under the outer rows of trees.

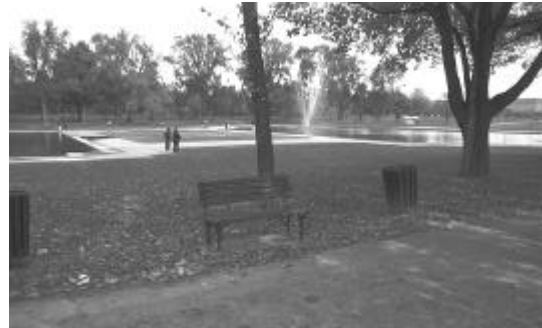
**Figure 54 – Cast iron frame benches and tulip trash receptacles used today along elm walks, November 11, 1996. LINC 11-12.**

**Trash Receptacles.** A limited number of trash receptacles were originally placed around the Reflecting Pool area. Photo documentation shows that a wire mesh trash can, placed directly on the ground, may have been the first type used. By 1964, the Park had introduced the wood and steel “tulip” style trash can. Although the *Streetscape Manual* recommends that a tulip style trash can for general refuse and one for recyclables be placed on each side of every bench, this arrangement has not been followed. There is an inconsistency in the spacing, and number of trash receptacles per bench, and it appears to be haphazard placement. Even though there is not the recommended number of trash cans along the walks, there still are twice as many receptacles as benches lining the main walks along the Reflecting Pool.

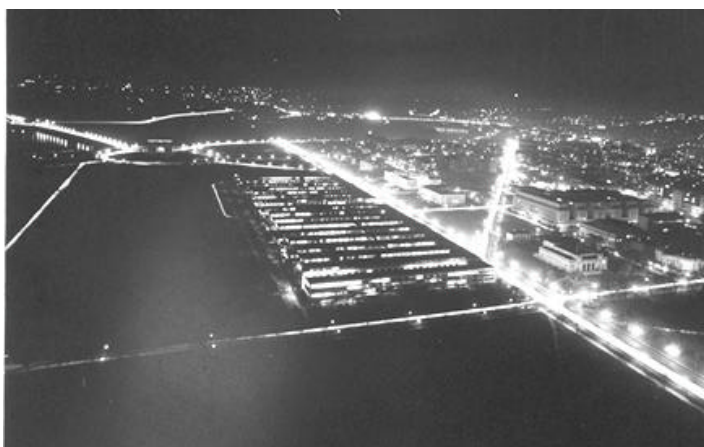
*Figure 55 - Reflecting Pool area devoid of lights. View from Washington Monument, April 1941. MRC 3-28.*

**Lighting.** Original plans did not designate lighting for the walkways and the Reflecting Pool. In 1935, temporary flood lights were set up at the eastern end and along the south side of the pool for night ice skating. “Twin-Twenty” lamps and posts, the double globe streetlight located along all major streets between the Capitol and the Potomac, were placed along the 17<sup>th</sup> Street corridor between Constitution Avenue and the Tidal Basin in the 1930s. The only lighting provided for the pool area is that coming from the “twin-twenty” globes on 17<sup>th</sup> Street and from lights adjacent to the study area.

Lack of direct lighting around the pools accentuates their reflective quality. Because of the subdued effect, the reflection of the Lincoln Memorial and the Washington Monument at night is both a breathtaking and memorable experience. Light emanating from the memorial, which was first lit from the inside in 1929, and from the grounds of the Washington Monument reinforce the structures as focal points and provide the soft light for the pools. The contrast in light also underscores the visual relationship between the memorial and the monument. Exterior lighting for the Washington Monument was installed by 1931, while exterior lighting at the Lincoln was developed in 1969.<sup>86</sup>

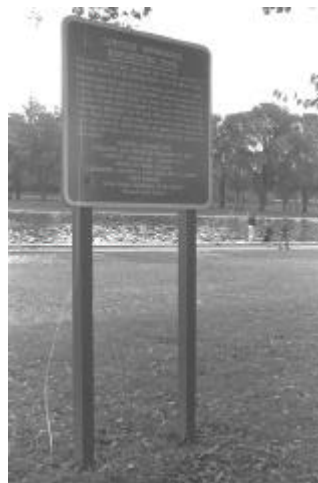
**Figure 56 - Oversized interpretive signs by the Reflecting Pool, November 11, 1996. LINC 11-16.**

**Signs.** In the Reflecting Pool area, the park has placed four large interpretive signs (two on each side) that describe the Reflecting Pool. The large metal signs (white lettering on brown background) block the view of the feature they are describing and are out of scale with the surrounding landscape. New interpretive signs are proposed for this area and will be a low-profile, tamper-resistant type, wayside.

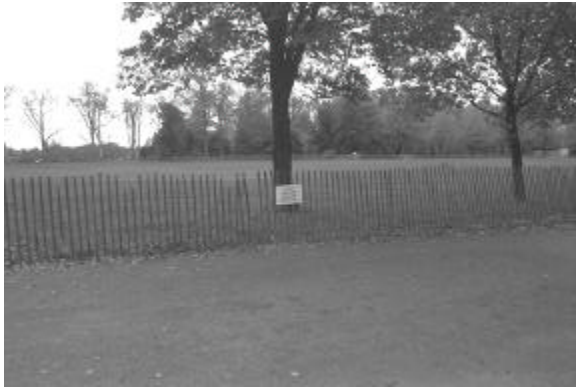
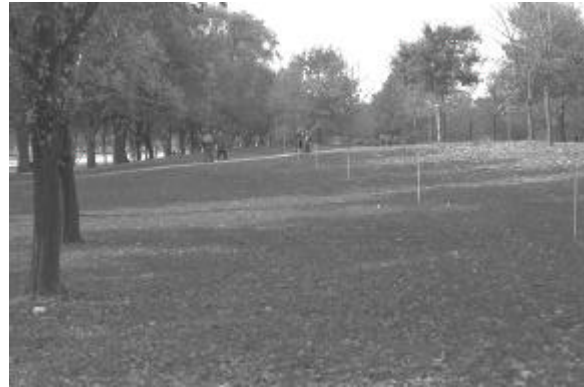
***Figures 57 & 58 - Temporary snowfencing installed along pedestrian corridors to protect grass areas. Stake and rope installed on the flood berm to mark secure area for landing pad, November 11, 1996. LINC 11-11 & LINC 11-14.***

***Pedestrian Barriers.*** In pedestrian areas, three different types of barriers are used within the Reflecting Pool area: stake-and-rope; snow fence; and chain-link fence. Park maintenance has installed these fences for a variety of reasons but mostly for the control of visitor circulation. The stake and rope and/or snow fence provide temporary protection of newly seeded areas and control circulation during special events. Also the stake-and-rope appears to be a permanent feature around the Rainbow Pool, which marks a secure area around a helicopter landing pad on a grassy panel between 17<sup>th</sup> Street and the Rainbow Pool. Other temporary barriers are used seasonally, such as the chain-link fence, to prevent visitors from walking on newly seeded areas along the Reflecting Pool or to prevent visitors from entering the fireworks staging area in the Rainbow Pool area.

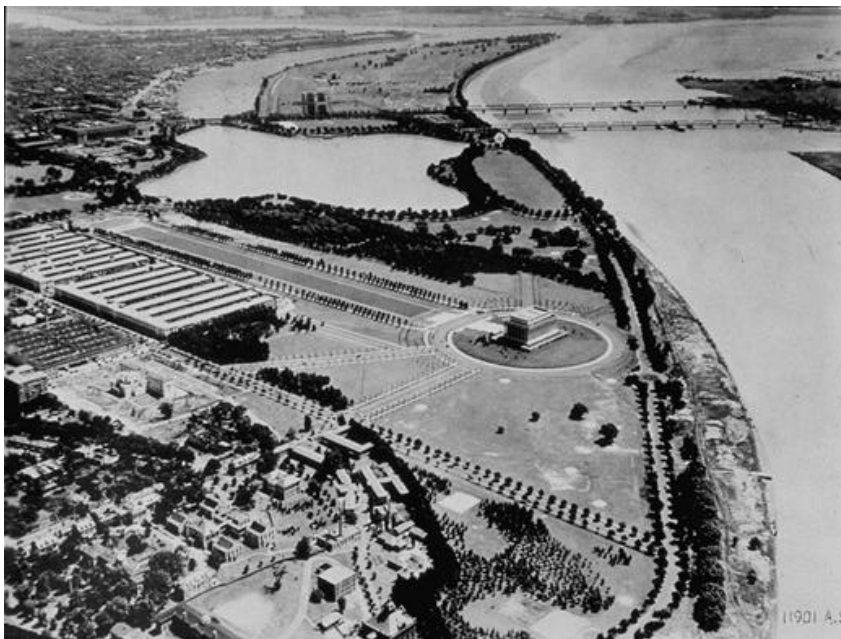
*Figure 59 - Aerial view of first phase of planting American elms along the radial and eastern side of Lincoln Circle, 1927. MRC 1-54.*

**Radial roads and outer circle.** In consultation with the Commission of Fine Arts and Frederick Law Olmsted, Jr (who was then serving on the Commission of Fine Arts) C.E. Howard, the landscape architect working for the Office of Public Building and Grounds, developed a tree planting plan for the area around the outside of the memorial circle and for the radial roads. The radial roads were eventually named 23<sup>rd</sup> Street NW, 23<sup>rd</sup> Street SW, Bacon Drive, and French Drive, with the two drives commemorating both the memorial's architect and the sculptor of the Lincoln statue. The 1916 plan featured a double row of trees, planted in opposite positions, on both sides of the radial roads. For the outer circle, the plan showed a single circular band of trees next to the circle in the grassy strip between the roadway and the sidewalk. Outside the sidewalk, four bands of trees were to be planted as though in concentric circles. However, in the second circular band, an incomplete curve of trees was indicated, which left a gap between the first and third band of trees.

When the first phase of the plan was implemented in the 1920s in the area east of 23<sup>rd</sup> Street, American elms (*Ulmus americana*) had been selected for the planting. Many trees were planted as “memorial trees” dedicated to outstanding individuals or groups as a living memorial. At that time, the proposed double row of oppositely planted trees on the radial roads was scaled back to planting in alternate positions, which reduced the number of trees and the density of the vegetation. The circular band of trees was followed

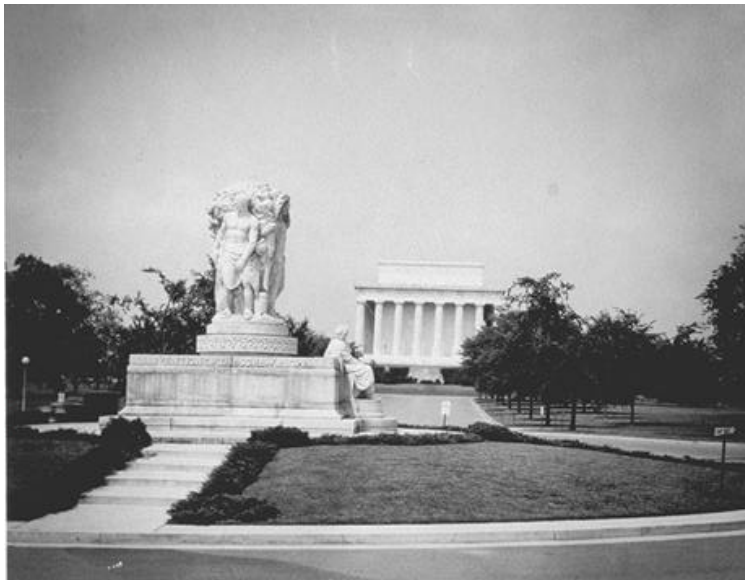
**Figure 60 - Ericsson Memorial and newly planted junipers around base, c. 1932. MRC 1-136.**

One other area beyond the memorial circle, the Ericsson Memorial site, received its own landscape treatment. When the Ericsson site was completed at the terminus of 23<sup>rd</sup> Street SW in 1932, the granite platform for the statue and the four sets of steps radiating out from the base, were enhanced with conifers. Three types of junipers (*Juniperus horizontalis*, *Juniperus sabina* var. *tamariscifolia*, *Juniperus squamata* 'Meyeri'), each displaying different growth habits, were planted.

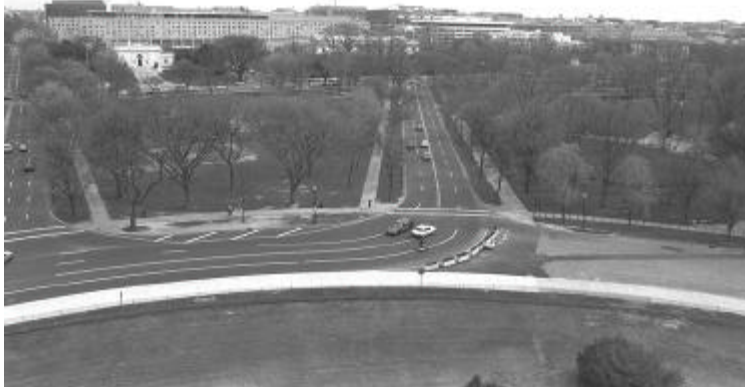
**Figure 61 - Remnant concentric row of elms around Lincoln Circle, between 23rd Street NW and Bacon Drive, March 1996. LINC 6-27.**

Since the National Park Service's stewardship began in 1933, it has attempted to maintain the original planting plan for the radial roads. Because Dutch elm disease (DED) has killed many American elms around the Lincoln Memorial, disease-resistant varieties have been planted to replace quite a few original trees. Although the number of mature trees growing along the radial roads varies, the spreading canopy of these trees remains an effective design element in the landscape.

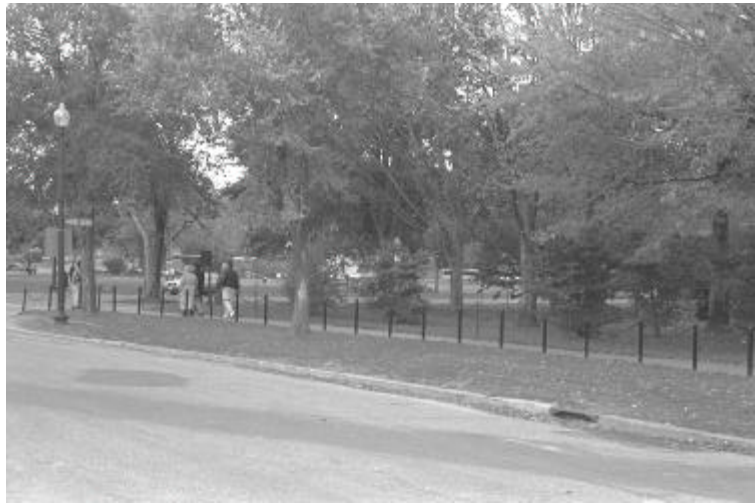
**Figure 62 - Inappropriate trees and shrubs, planted under canopy of American elms, November 11, 1996. LINC 11-27.**

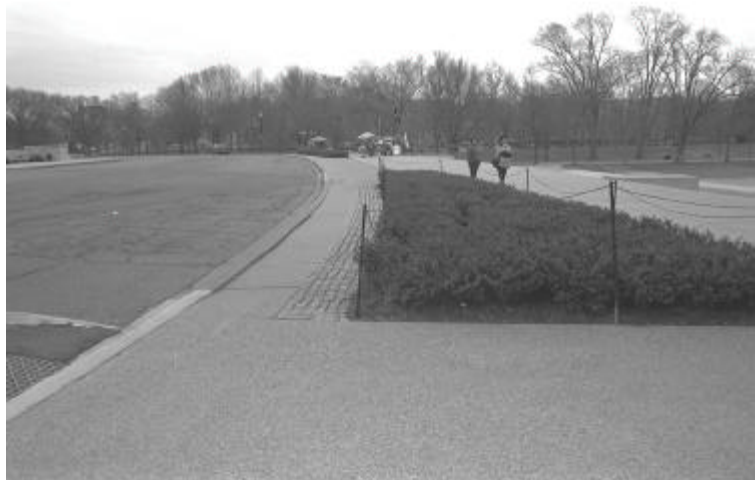
**Figure 63 - Shrub planting at top of Reflecting Pool steps, December 1996. LINC 17-35.**

The only significant alteration to the original landscape plan occurred in 1953 when the outer edge of the circular roadway near the sidewalk above the Reflecting Pool was changed. Here a rectangular curb cut was eliminated, the circle was made continuous, and a pair of planting beds were installed on the north and south side of the sidewalk in the areas formerly shaped by the old squared-off curb. The park appears to have planted dwarf boxwood in the beds, which were replaced in 1977 with a little leaf holly, also known as inkberry (*Ilex glabra*.) At subsequent intervals, the park replaced the inkberry with Japanese hollies (*Ilex crenata*.) which occupy the planting bed today.

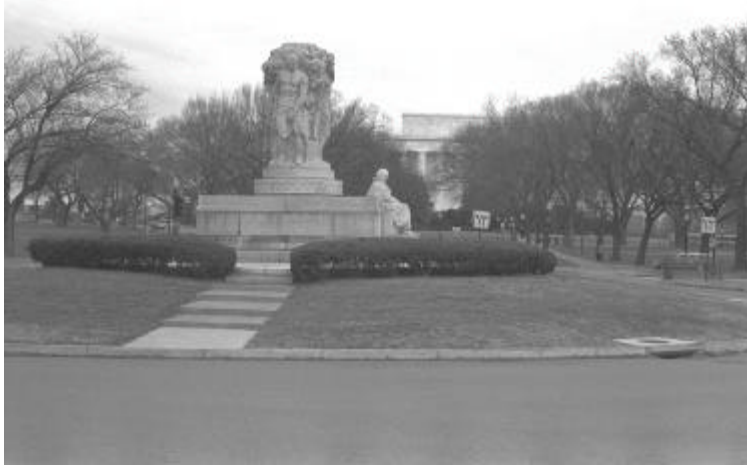
**Figure 64 – Replacement shrubs around Ericsson Memorial changes the character of the original planting, February 1997. LINC 18-8.**

Around the Ericsson Memorial, the planting plan was changed substantially. Japanese holly replaced the original junipers, which once encircled the granite platform. Four walks, which radiated from the granite platform, also were lined with junipers, but these shrubs were also removed and now the walks are surrounded by grass. These changes have further downplayed the connection of the Ericsson Memorial to the Lincoln Memorial landscape.

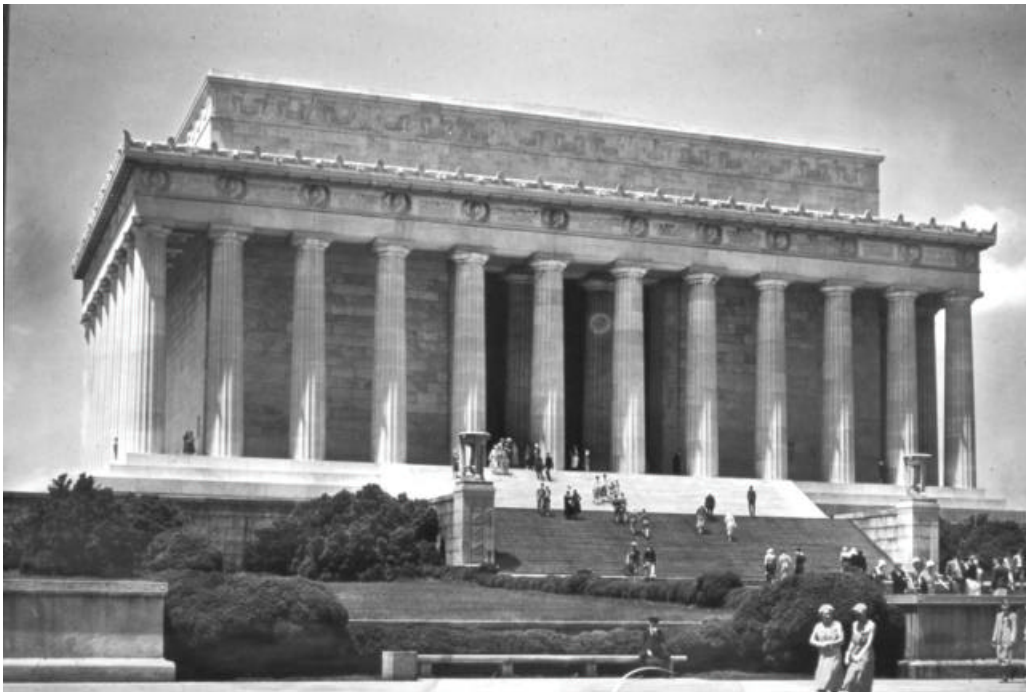
**Figure 65 - East side of Lincoln Memorial showing mature boxwood and yew shrubs, 1935, by Orren R. Loudon. Used by permission from the National Geographic Society.**

**Inner Circle.** In contrast to the radial roads, plans developed for the area immediately inside the circle used a variety of broadleaf evergreen shrubs and trees as foundation plantings for the memorial building. Since the structure had been constructed on a raised terrace and elevated some 14 feet above grade, vegetation was needed to both soften the edge of the granite walls of the raised terrace and to provide large masses of green at the base of the wall. These schemes were developed to bring the building more in scale with its surrounding landscape.

The first approved plan from 1920 showed plantings for the inner circle concentrated on the front, or east, side of the building, with a few shrubs along the north, south, and west sides. On the east side of the inner circle, two rectangular planting beds, each containing a granite bench and surrounded on three sides by walls of granite block, framed the entry to the memorial approachway. Two mature dwarf boxwood (*Buxus sempervirens* 'Suffruticosa') shrubs were planted within each of the walled beds beside the benches. Behind the benches a short dwarf box hedge served as a backdrop. An additional mature dwarf boxwood was placed adjacent to the far, outside wall of each planting bed. Behind the entry planting beds, hedges of dwarf boxwood lined the outer edges of the pavement along the entire length of the approachway. To accentuate the grade changes that occurred in the approachway, the design called for a larger dwarf boxwood to be placed adjacent to the successive sets of steps that marked each change in level. At the base of the raised terrace wall, groups of common boxwood (*Buxus sempervirens*) and English, Canadian, and Japanese yew (*Taxus* sp.) were planted. In addition to these massings, dwarf boxwood were planted in front of some the groups. The corners of the raised terrace wall were emphasized on the northeast and southeast with plantings extending out from the wall into

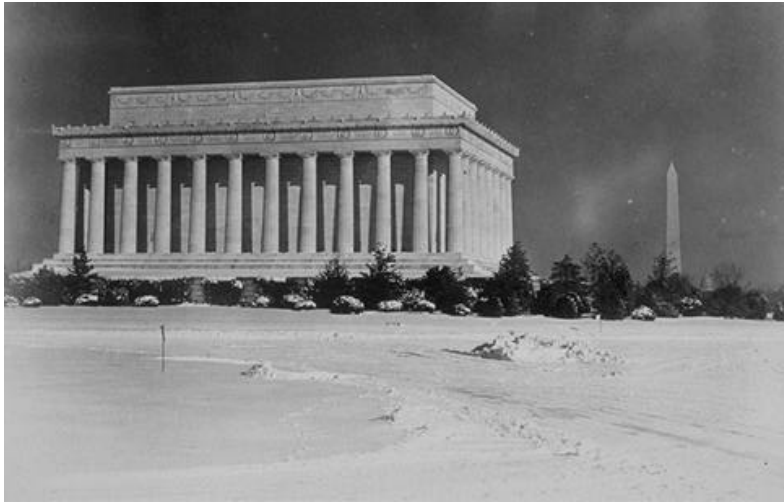
**Figure 66 - West side or rear of Lincoln Memorial showing newly planted foundation plantings, c. 1932. MRC 2-20.**

The design in the second approved plan from 1931 was primarily for the rear of the memorial. Several broadleaf evergreen trees were selected for this side to supplement the overall planting and to create a different effect than that on the front. In addition to common box and dwarf box, American holly, and southern magnolia (*Magnolia grandiflora*) were used to complete the palette. To anchor the rear, magnolias were strategically sited, American hollies were intermixed near the magnolias and common and

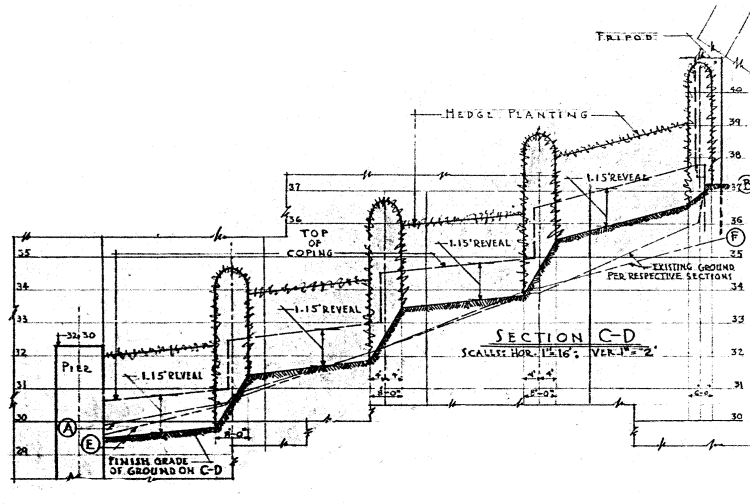
Figure 67 - Section showing desired character of replacement hedge along approachway, 1944. NPS Map 801/80347.

overgrown. When the park revised the original plans by replacing the boxwood hedges with yews in 1945, they altered the character of the entry planting, yet retained some of the historic integrity by keeping a band of green hedge growing on both sides of the approachway. However, the addition of an American holly and the Japanese hollies to the front side and massings of yews to screen floodlights have further compromised the character of the planting design. Because replacement plantings have deviated from the original design, the landscape on the front side retains a lower degree of integrity. On the sides and rear of the memorial, the integrity of the plantings is mostly intact, although some boxwood planted near the magnolias and close to the raised terrace have been shaded out and are unhealthy, or have died. At the midpoint of the north and south sides, two thick masses of *Taxus cuspidata* 'Nana' provide the horticultural transition between the character of the two different planting areas. Even though these yews were planted to replace the original mugo pines, the design intent of keeping a lower growing conifer mass in this area is still evident. In other areas overgrown plant material, like some American hollies that were planted on either side of the horizontal-growing yew mass on the north face of the memorial, are encroaching upon the designed opening above the raised terrace. See Map 15 and Map 16 *Lincoln Circle - Vegetation* for the graphic representation of the front and back plantings.
